Manhole Inspection Summary

Manhole # S41EE_035MH

Insp Date: **1/9/08 12:08 PM**

Location Address: **1036 SOMERSET ST**

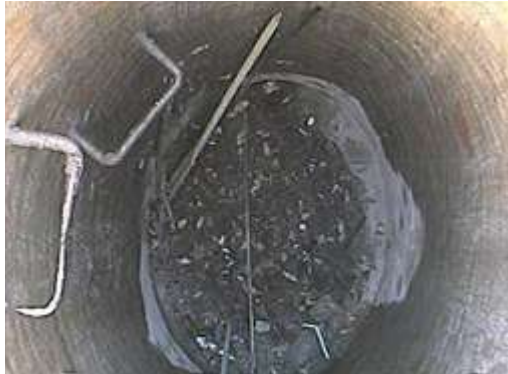
Defect 2

Count: **4** Missing: **3** ☒ **Corroded**

STEPS CORRODED

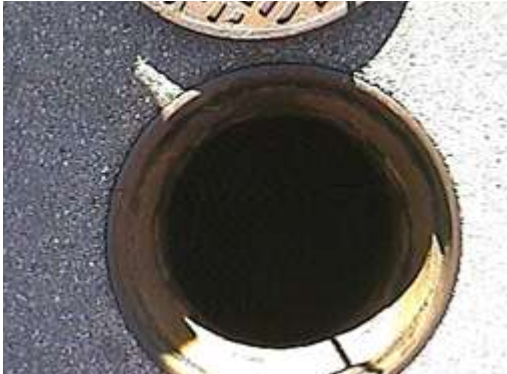
Defect 1

Offset: **2** (in.)

FRAME OFFSET

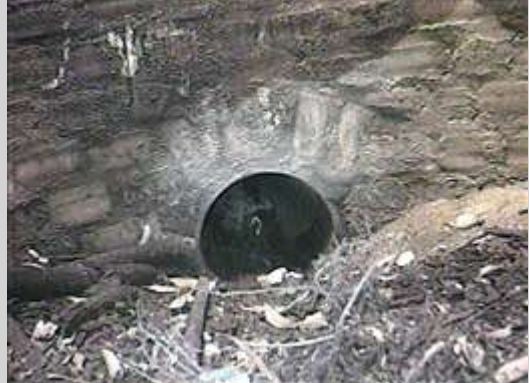
12 O'Clock Outflow

8 in. Circular Gravity Sewer
Pipe Out @ 12 O'Clock

Infiltration: **None** Pipe Seal Cond: **Sound**
